## Arecibo Telescope Collapse Forensic Investigation

Thornton Tomasetti

**July 25, 2022**

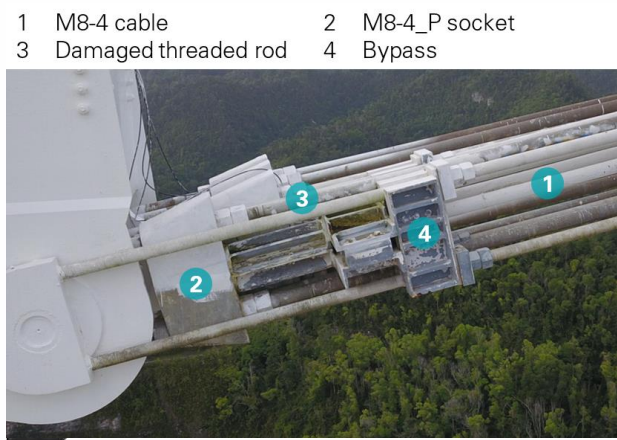
Figure 11: Damaged rod bypass at platform end of cable M8-4  
*(photo: NAIC Arecibo Observatory, a facility of the NSF).*

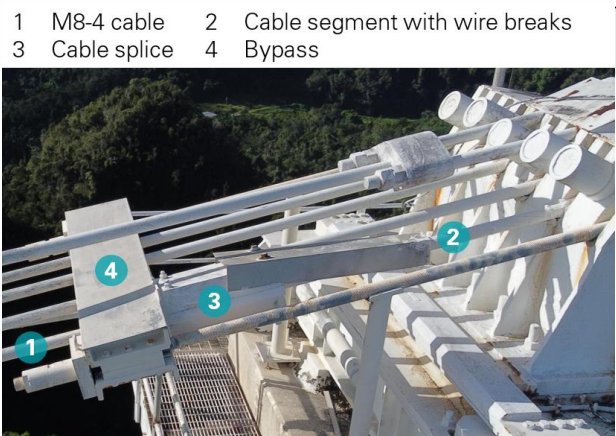
Apart from the second upgrade, three significant changes were made to the cable system. In 1981, one of the original backstays of Tower 12 was replaced after six wire breaks were discovered in the cable over time. Then in 1997, a threaded rod connecting the platform-end socket of cable M8-4 was accidentally damaged while implementing the second upgrade of the telescope. A structural bypass was installed to catch the socket should the damaged rod fail (Figure 11). In 2014, a splice near the tower end of the same M8-4 cable was bypassed after multiple wire breaks were discovered during an inspection (Figure 12).

Figure 12: Cable splice bypass near tower end of cable M8-4  
*(photo: NAIC Arecibo Observatory, a facility of the NSF).*

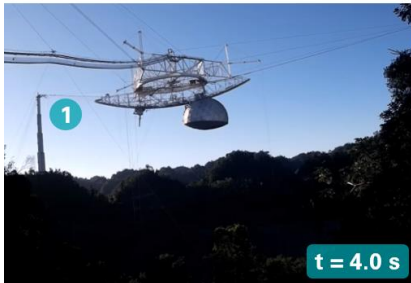
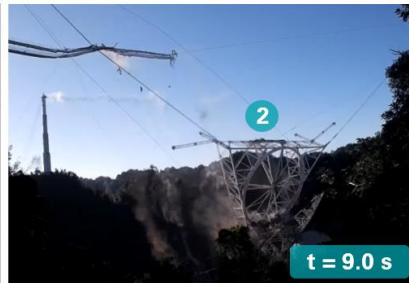
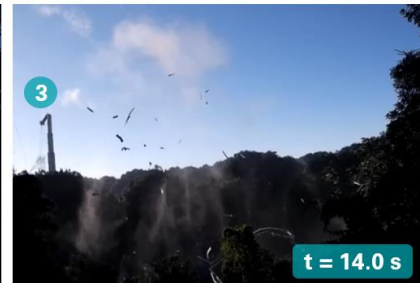
At 7:54 AM local time on December 1, 2020, cable M4-2 failed at its socket at the top of Tower 4, once again without any significant wind or seismic activity. This third cable failure was immediately followed by the failure of the remaining two original mains at the top of Tower 4, initiating the fall of the suspended structure. The suspended structure swung down while still connected to Tower 8 and Tower 12, and impacted a cliff face between these two towers. During the fall, the azimuth arm detached from the platform and fell through the reflector. Finally, the top of the three towers broke off and fell (Figure 19).

Figure 19: Telescope collapse sequence, looking south.  
(Still images of collapse video by NAIC Arecibo Observatory, a facility of the NSF.  
Intermediate still images are in provided Appendix E.)

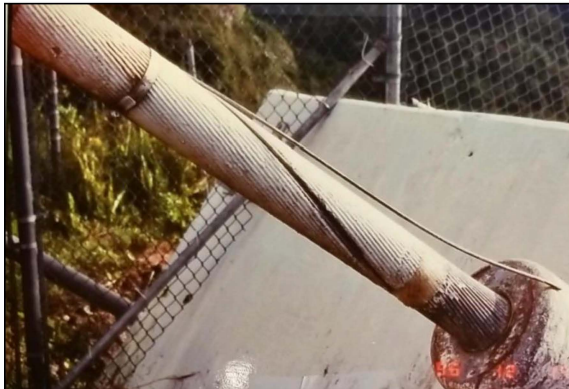
Figure 20: Single wire break observed at ground end of cable B4-1 on 12/12/1996  
(photo: NAIC Arecibo Observatory, a facility of the NSF).

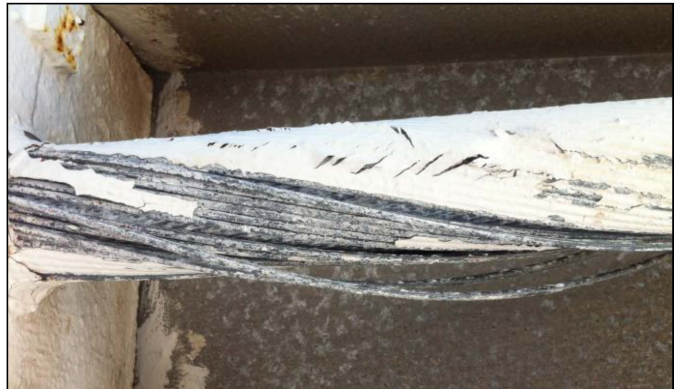
Figure 21: Multiple wire breaks observed at splice near tower end of cable M8-4 on 1/14/2014  
(photo: NAIC Arecibo Observatory, a facility of the NSF).

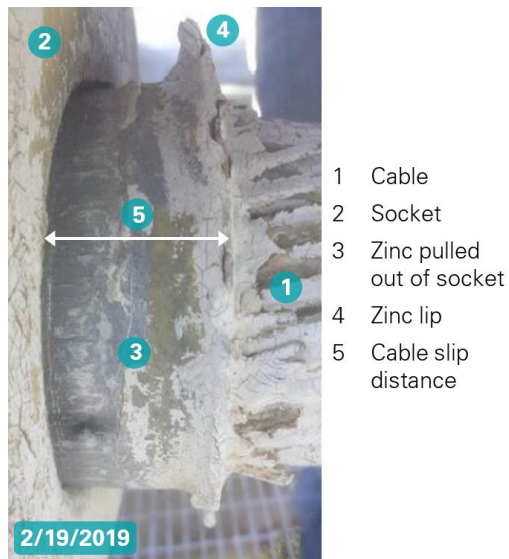
Figure 23: Last known cable slip (1.125 inch) at socket M4N\_T, where first cable failure occurred (photo: NAIC Arecibo Observatory, a facility of the NSF).

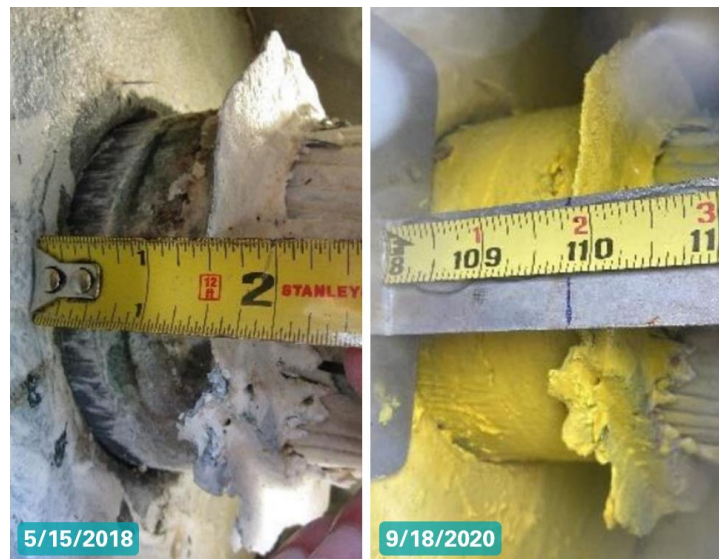
Figure 24: Cable slip increase measured at socket B12W\_G (photos: NAIC Arecibo Observatory, a facility of the NSF).

The cable slips were measured at the tower and ground ends of the auxiliary cables after the first cable failure, and at the platform ends after the collapse (Figure 25). One-third of the cable slips exceeded the AASHTO limit of one-sixth of the cable diameter. The maximum cable slip was observed at the ground end of B12W, and had increased from 1.5 inches in May 2018 to over 1.75 inches in September 2020 (Figure 24).

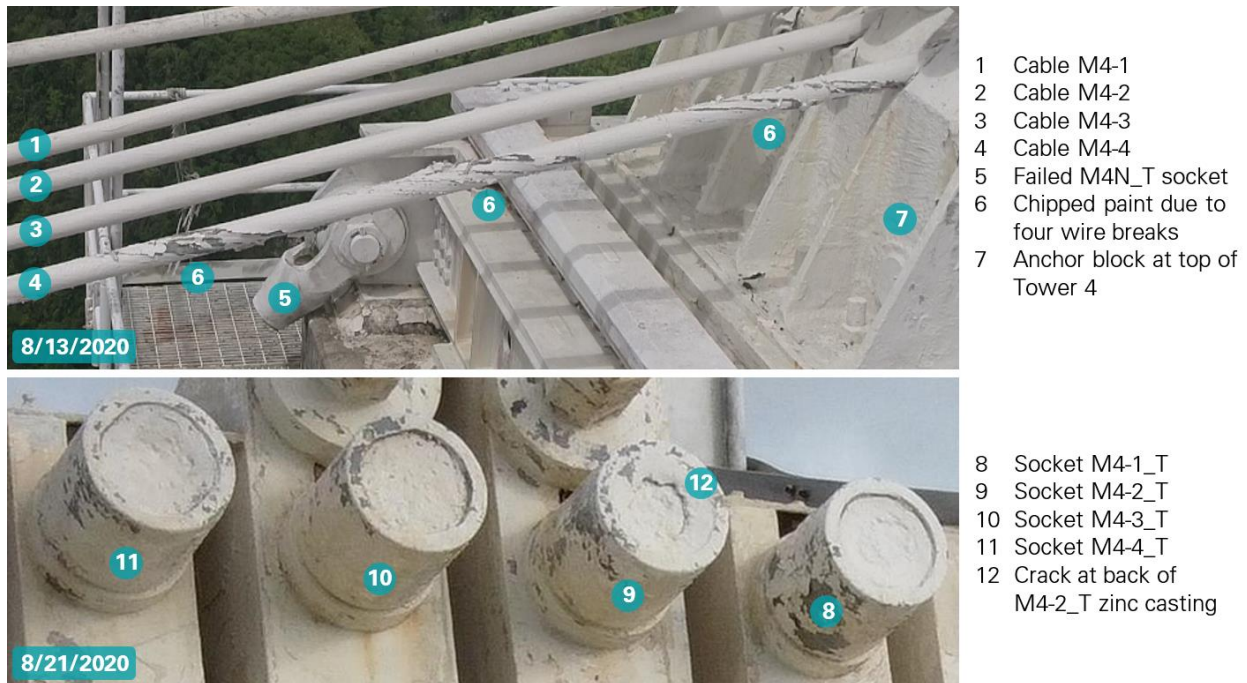
Figure 26: Damage on original M4 cables at top of Tower 4 after first cable failure  
(photos: NAIC Arecibo Observatory, a facility of the NSF).

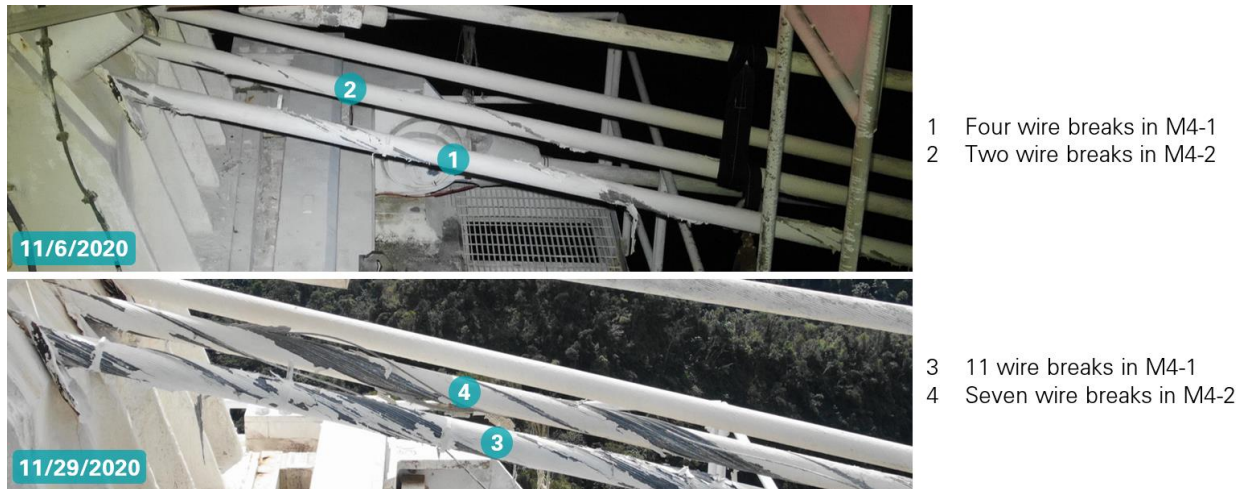
In the three weeks following the M4-4 failure, seven and five additional wires breaks were observed at the tower end of M4-1 and M4-2, respectively (Figure 27). The zinc casting of the M4-2 socket continued to deform with signs of crack movement at the back face of the casting (Figure 28).

Figure 27: Wire break development after second cable failure  
(photos: NAIC Arecibo Observatory, a facility of the NSF).

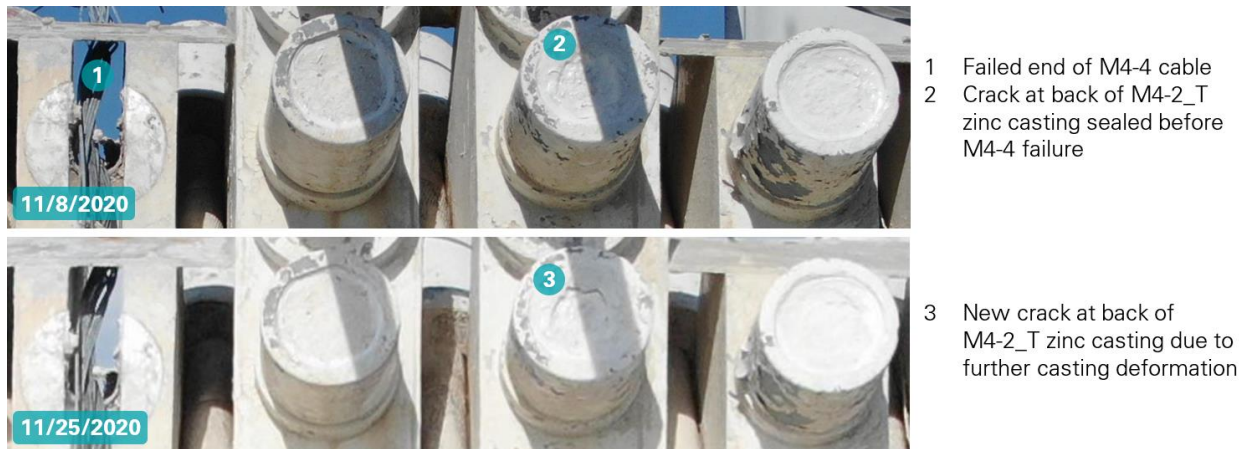
Figure 28: Evidence of socket casting core displacement after second cable failure  
(photos: NAIC Arecibo Observatory, a facility of the NSF).

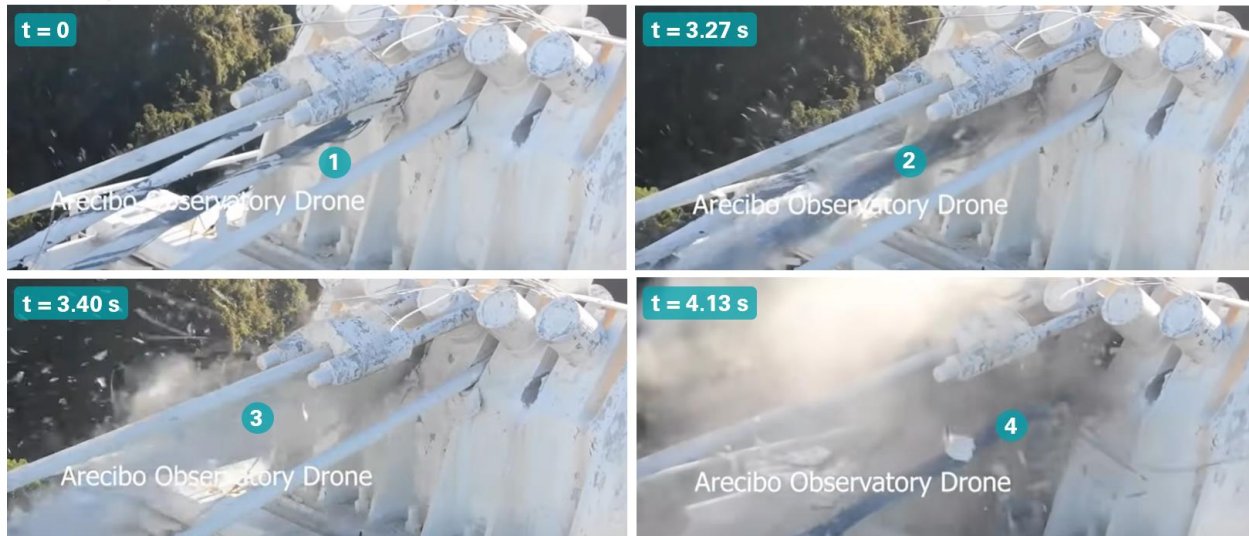
Figure 29: Progressive failure of original main cables at top of Tower 4.  
(still images of drone video by NAIC Arecibo Observatory, a facility of the NSF.  
Intermediate still images are provided in Appendix E.)

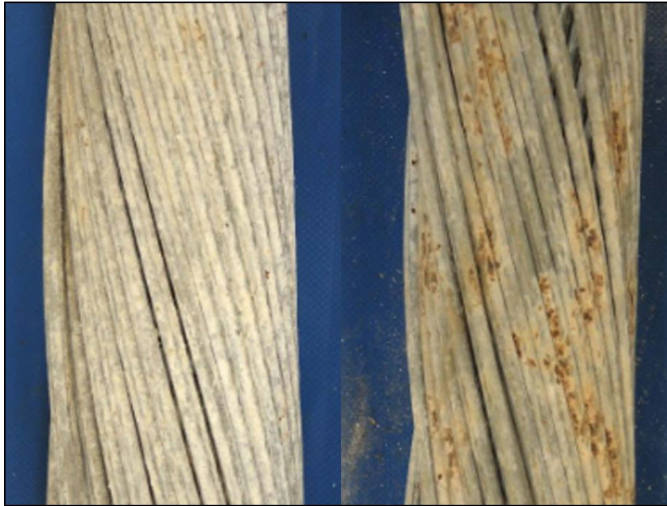
Figure 30: Oxidation of galvanizing zinc (left) and wire steel (right) in second wire layer of an original M4 cable (photos: Socotec).

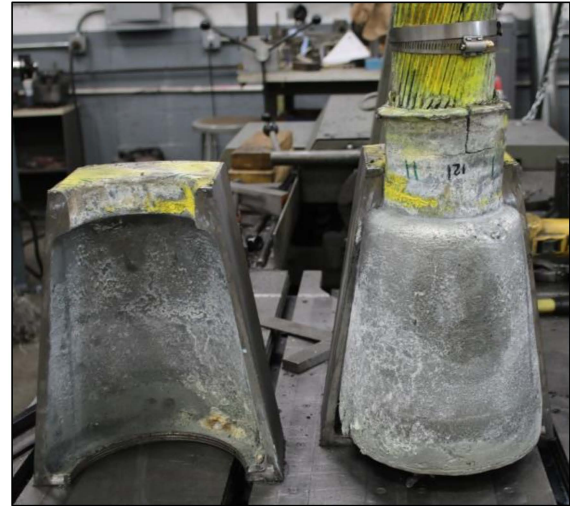
Figure 31: Surface corrosion of B12W\_G socket casting (photo: Socotec).

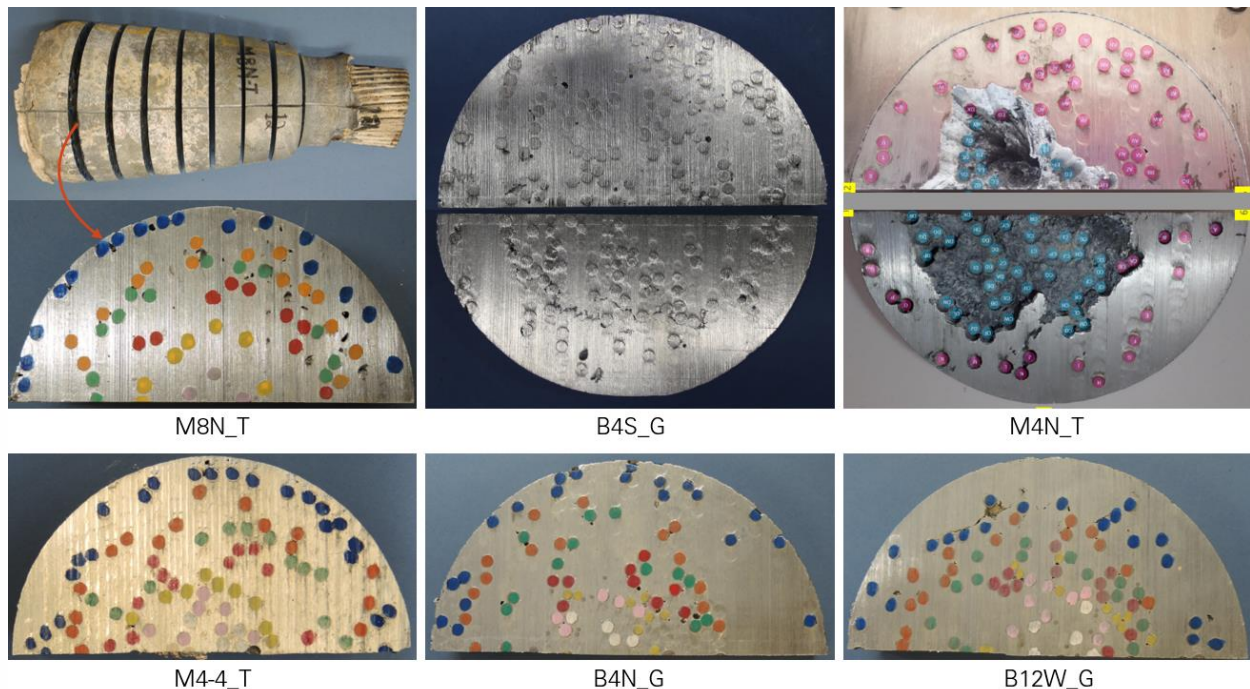
During socketing, the cable's wires are spread out inside the socket to form a broom before pouring zinc. The casting of socket M4-4\_T (second cable failure) and four auxiliary sockets (M8N\_T, B4N\_G, B4S\_G, B12W\_G) that exhibited different degrees of cable slip were cut in the transverse direction to observe the wire broom. As shown in Figure 32, the wire brooms are irregular, and differences in wire distribution between the center and perimeter of the casting can be observed. Additional observations and results on the wire broom geometry are provided in Appendix M.

Figure 32: Wire distribution at back of socket castings (*M4N\_T* photos: WJE<sup>15</sup>; other photos: Socotec).

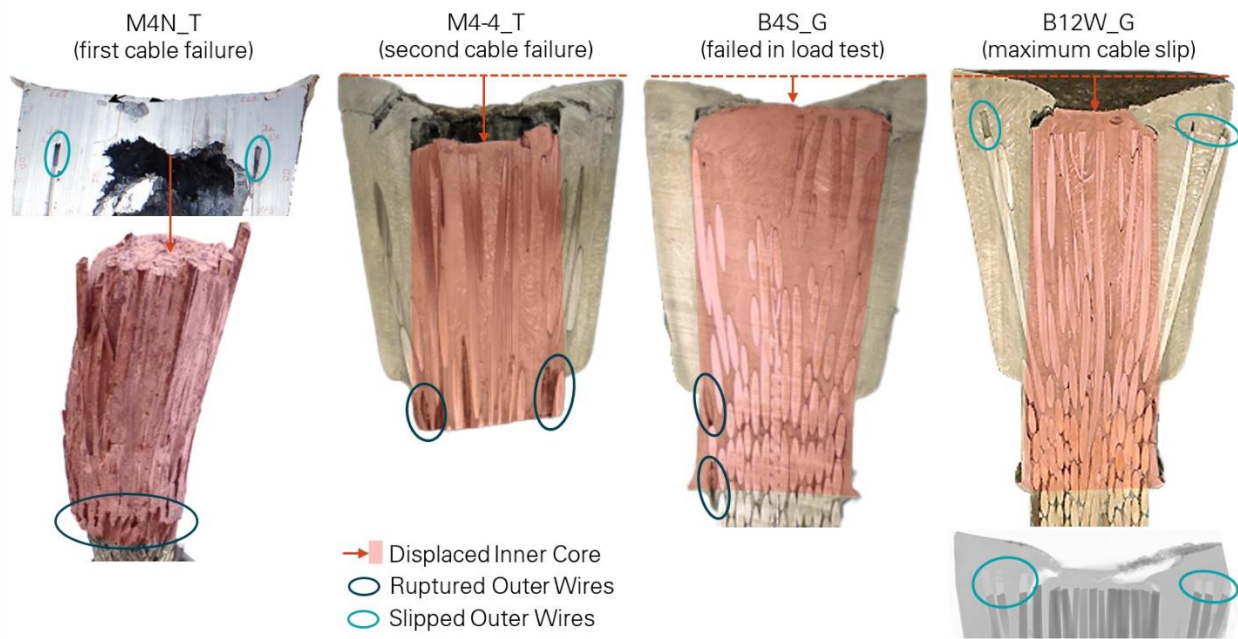
Figure 33: Observations in distressed sockets (M4N\_T photos: WJE<sup>16</sup>; B12W\_G radiograph: Adrian Brügger, Columbia University - Oak Ridge National Laboratory; other photos: Socotec).

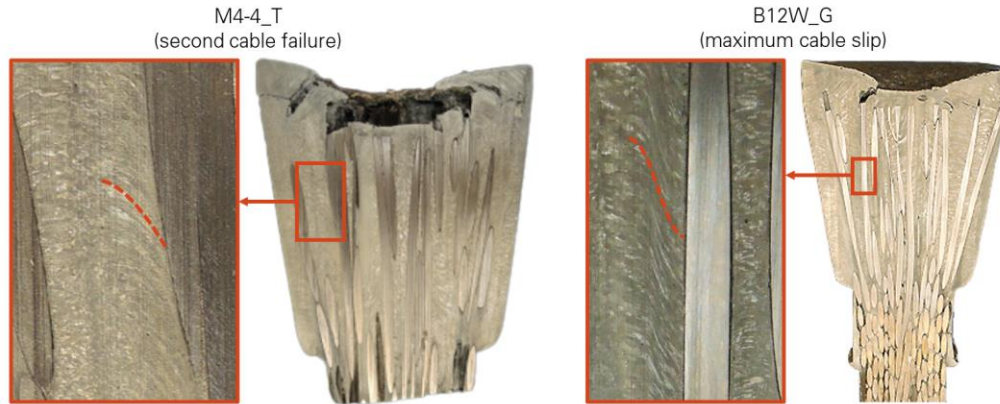
Figure 34: Evidence of grain flow near surface of displaced core in socket zinc casting (photos: Socotec).

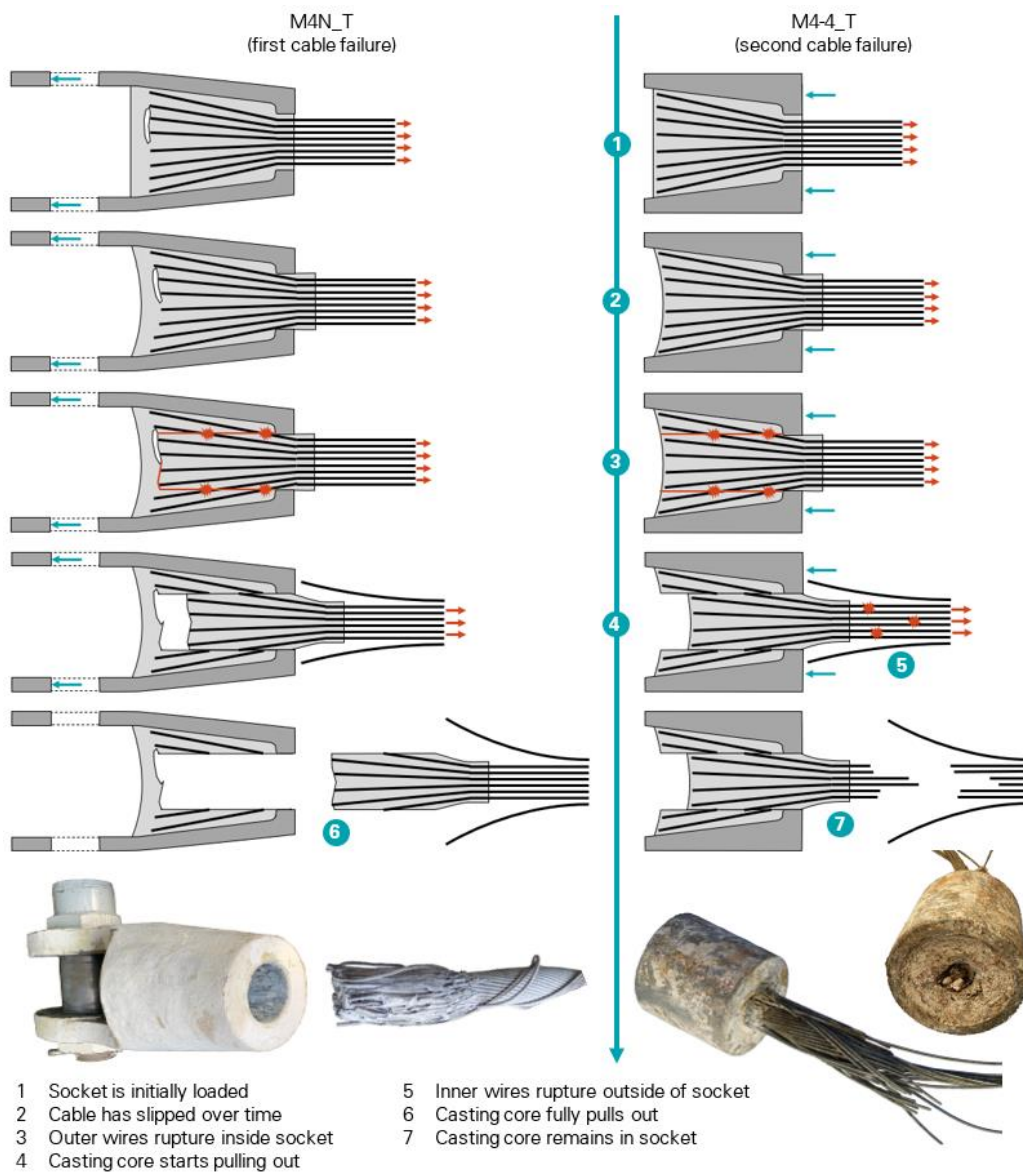
The inner core and the inner wires completely pulled out of the first socket that failed (M4N\_T). In the second socket that failed (M4-4\_T), the core remained in the socket after shifting significantly and the remaining wires ruptured outside of the core. As a result, the two failed sockets look different yet both failures started inside the socket with a displacement of the core and the rupture of outer wires (Figure 35).

Figure 35: First two socket failures  
(M4N\_T socket photo: NAIC Arecibo Observatory, a facility of the NSF; M4-4\_T photos: Socotec).

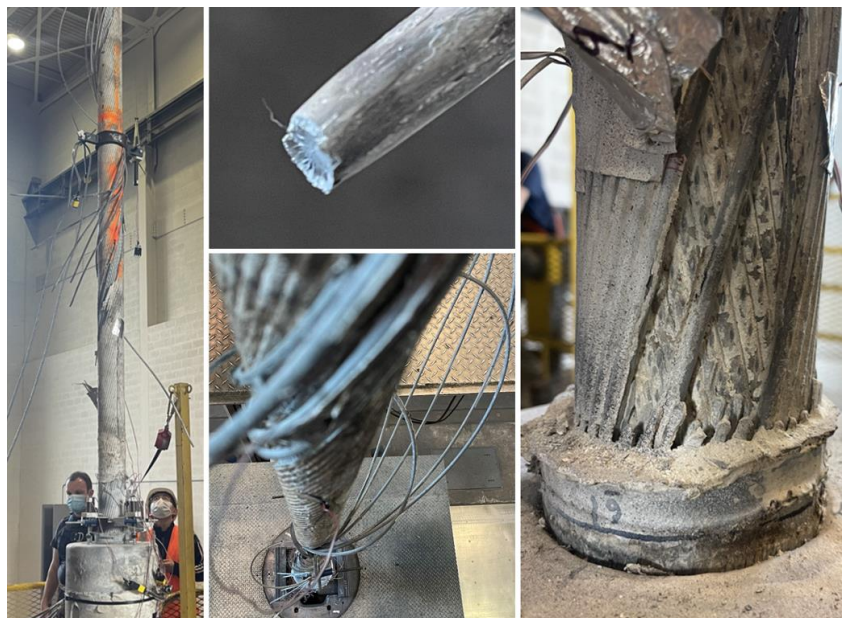
Figure 56: Failed wires in B4S\_G socket at end of load test.
