Emergency Cleanup

**NOV
2021**
UPDATED
DEC 2021

The National Science Foundation (NSF), University of Central Florida (UCF), Arecibo Observatory, and a team of contractors are performing emergency cleanup activities after the collapse of the Observatory's 305-meter radio telescope on December 1, 2020.

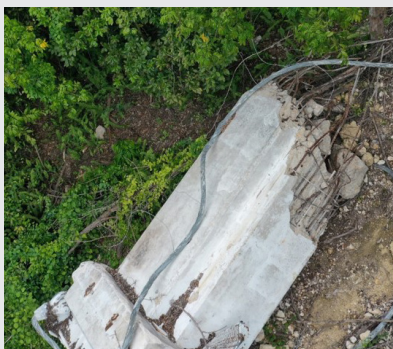
One of two fallen pieces of Tower 4 down the hill side

- Safely recovered two large concrete pieces from Tower 4 that had fallen down a slope as a result of the collapse, thereby preventing potential slippage down the hillside and implemented stormwater pollution prevention measures during this work, per the National Pollutant Discharge Elimination System Construction General Permit.

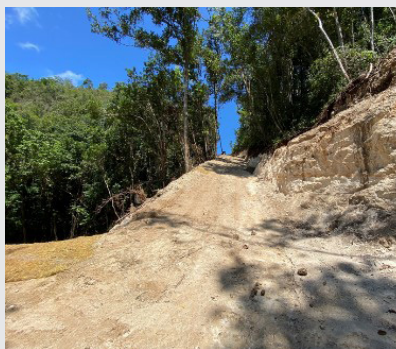
Tower 4 temporary access road

As part of the effort to retrieve two fallen pieces of Tower 4, NSF conducted informal consultation with USFWS to inform the planning for these emergency actions during May-June 2021. As a result, the team implemented measures to prevent loose soil from the construction of a temporary road from entering a nearby stream; conducted a tree and plant inventory to identify potential protected species; took measures to protect an identified rare fern; and followed protocols to protect the Puerto Rican boa. The retrieval effort is now complete and the site is being revegetated to its natural condition.

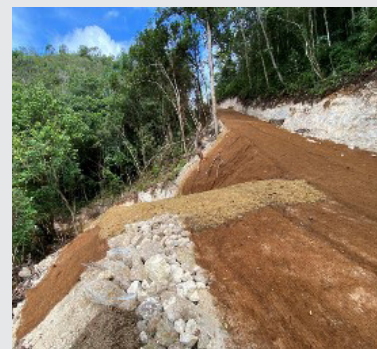
Erosion control measures after Tower 4 pieces recovered

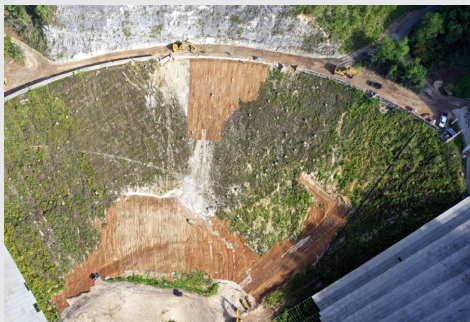
2 Rim wall repairs and erosion control measures

Once the fallen platform was removed (Figure 1), the team began repairing approximately 225 feet of concrete rim wall and installing erosion control measures, including the use of coconut fiber matting and seeding, to stabilize the slope under the reflector area and encourage native vegetation growth (Figure 2).

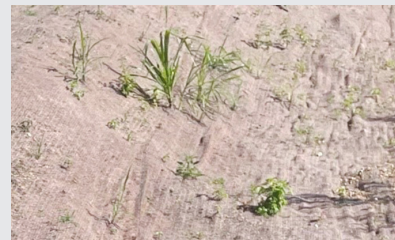
3 Coconut matting for site stabilization

The coconut matting provides a better substrate than bare soil because it encourages seed growth, anchors natural vegetation as it grows through the matting, and accelerates site stabilization (Figure 3).

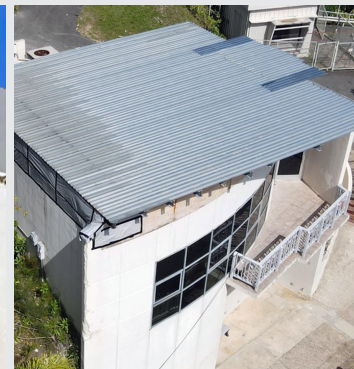
5 Learning Center temporary roof

Because of the significant damage to the Learning Center roof caused by fallen cables (Figure 4), the team has installed a hurricane-proof temporary roof to stabilize and protect the structure until permanent repairs can be made (Figure 5). At the Science and Visitor Center (Figure 6), the repair of minor damage to the building's roof structure and observation deck roof has been completed.

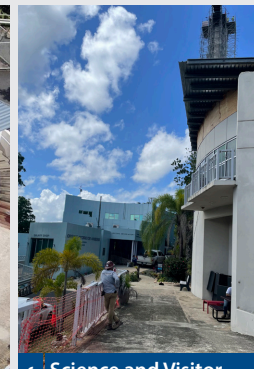
6 Science and Visitor Center area
