## Arecibo Telescope Collapse Forensic Investigation

Thornton Tomasetti

**July 25, 2022**

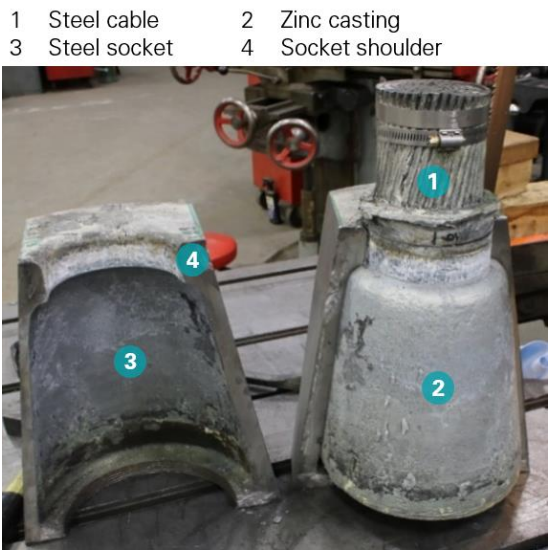
Figure 5: Zinc casting of auxiliary backstay socket B4N\_G (photo: Socotec).

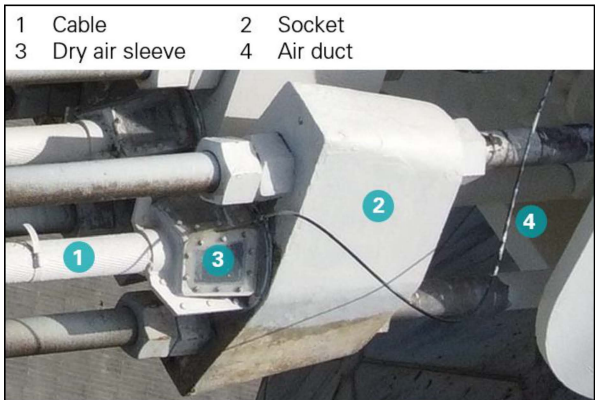
In the late 1960s, AO observed that the cables were not fully airtight in the transition zone between cable and socket, and determined that this could lead to corrosion within the cable due to moist air intrusion and condensation. In 1972, a system of sleeves, air compressors and dryers was installed at the lower end of the cables to circulate dry air through the cables and prevent accumulation of moisture (Figure 9). The same moisture exclusion system was installed on the auxiliary cables during the second upgrade in 1997. While the system appeared to be functional, condensation was occasionally reported in some of the dry air sleeves between 2002 and 2011. We also observed water accumulation in some of the dry air sleeves during our site visits before and after the collapse.

Figure 9: Dry air sleeve on M8-1\_P socket  
*(photo: NAIC Arecibo Observatory, a facility of the NSF).*

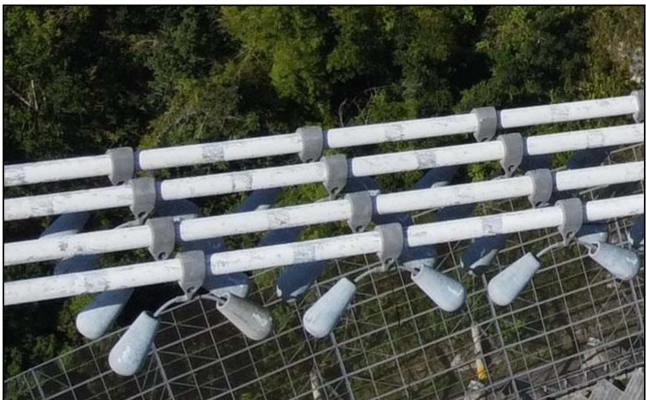
The cables of the telescope experienced wind-induced vibrations immediately after construction in 1964. Stockbridge dampers (Figure 10) were installed to mitigate the vibrations and appear to have been effective, even though vibrations continued to be reported between 1970 and 2011. The vibrations were

reported as “slight to moderate”<sup>10</sup> and seem to have occurred relatively infrequently and only under specific wind conditions.

Figure 10: Stockbridge dampers on original M4 cables  
*(photo: NAIC Arecibo Observatory, a facility of the NSF).*

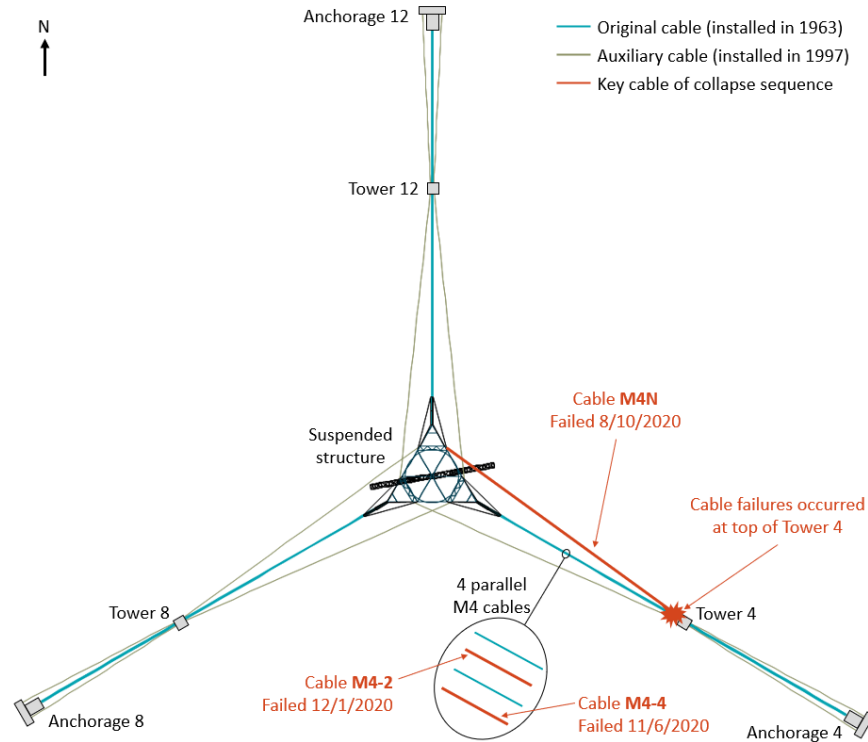
At 2:36 AM local time on August 10, 2020, cable M4N pulled out of its socket at the top of Tower 4 (Figure 18). This first failure occurred as the telescope was operating normally, with the azimuth arm rotating with respect to the platform and the Gregorian shifting along the bottom of the azimuth arm. There were no particularly strong winds or any significant earthquake during that night. The telescope continued to operate (azimuth arm and Gregorian movement) for approximately 20 minutes after the cable failure, before being stopped by the operator. Several wire breaks were observed three days later in adjacent cables at the top of Tower 4, and likely occurred when M4N failed (details in Section 3.2.1).

At approximately 10 PM local time on November 6, 2020, cable M4-4 failed at its socket at the top of Tower 4. This occurred in the absence of high winds and seismic activity. This second cable failure caused new wire breaks at the top of tower 4 (details in Section 3.2.1). In the three weeks following the second cable failure, multiple additional wire breaks occurred in the remaining main cables at the top of Tower 4 (details in Section 3.2.1).

At 7:54 AM local time on December 1, 2020, cable M4-2 failed at its socket at the top of Tower 4, once again without any significant wind or seismic activity. This third cable failure was immediately followed by the failure of the remaining two original mains at the top of Tower 4, initiating the fall of the suspended structure. The suspended structure swung down while still connected to Tower 8 and Tower 12, and impacted a cliff face between these two towers. During the fall, the azimuth arm detached from the platform and fell through the reflector. Finally, the top of the three towers broke off and fell (Figure 19).

Figure 18: Cable failure locations.

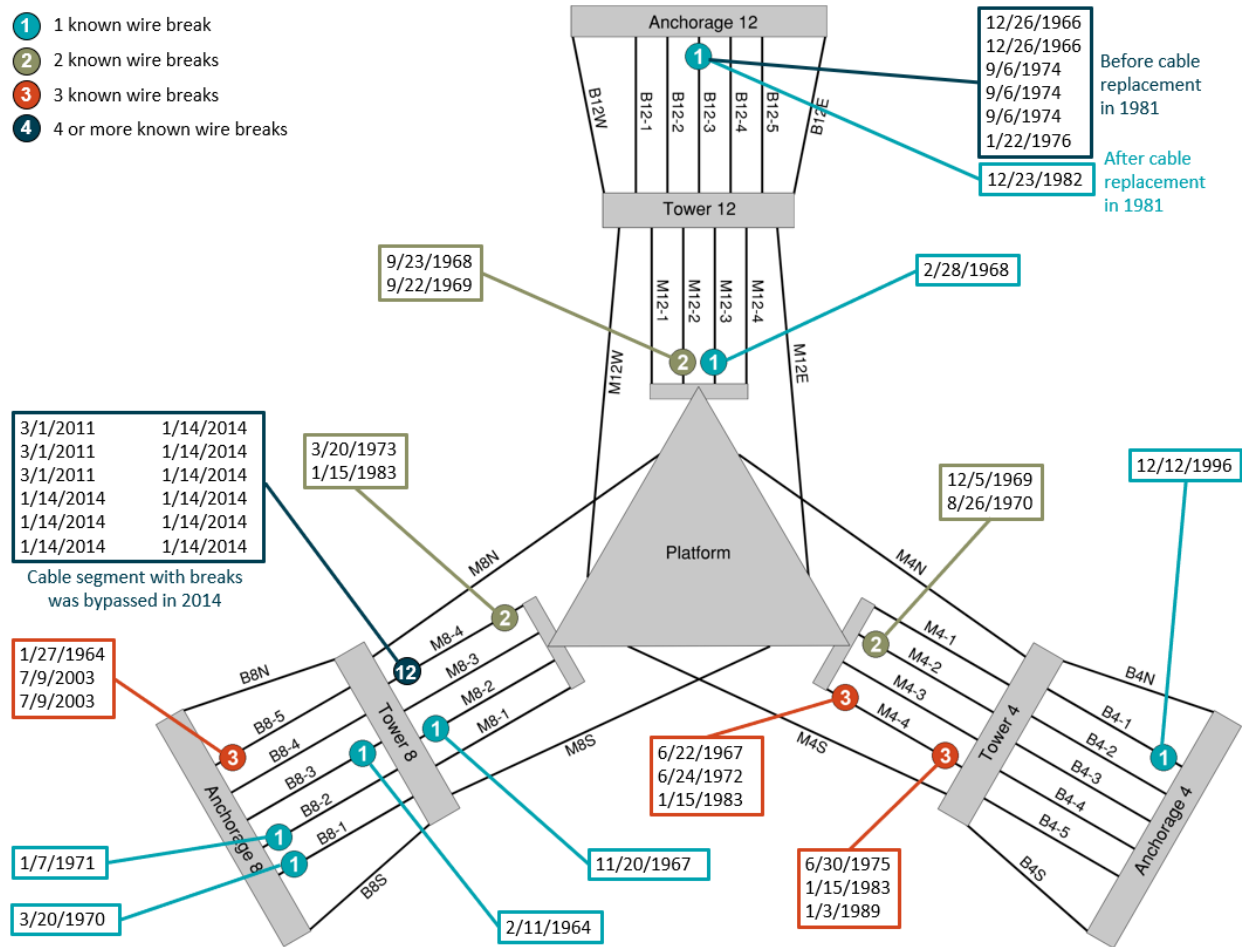
Each main and backstay cable is made of 126 to 216 steel wires, and individual broken wires were occasionally discovered near the cable ends throughout the structure's life (Figure 20). A total of 40 wire breaks had been reported before 2020 (Figure 22). No more than three wire breaks were reported at each cable end, with two exceptions: six breaks at the bottom of a backstay cable, which was subsequently replaced, and 12 breaks near a cable splice (Figure 21), which was subsequently bypassed. Only the breaks that occurred in the outer layer of wires were visible and therefore counted.

Figure 22: Wire break locations and report dates.

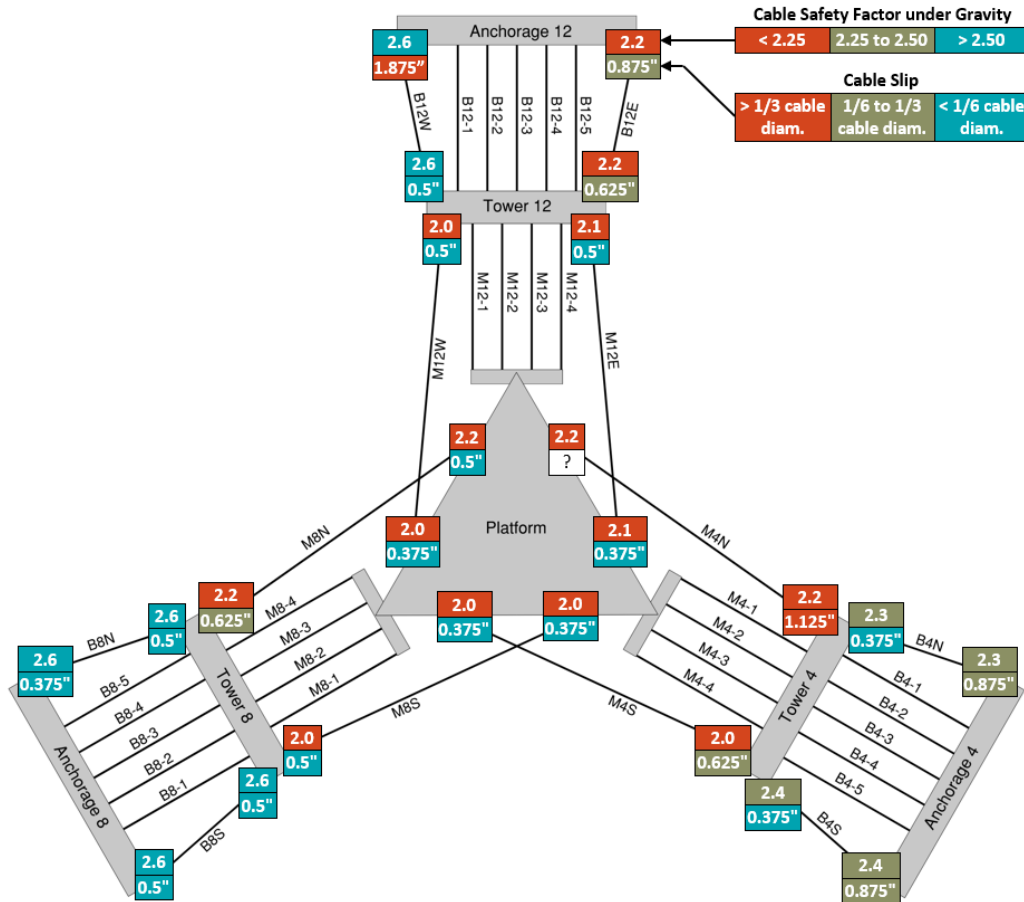
The cable slips were measured on all of the auxiliary cable sockets after the telescope's collapse, except for the first socket to fail (Figure 25). There is no consistent correlation between the cable slips and safety factors, which indicates that the cable slip at a socket does not only depend on the cable tension. The safety factors in Figure 25 are based on the actual cable tensions under gravity loads, determined through analysis (section 4.1.2).

Figure 25: Cable safety factors and measured cable slips on auxiliary cable sockets.

The cable slips were measured at the tower and ground ends of the auxiliary cables after the first cable failure, and at the platform ends after the collapse (Figure 25). One-third of the cable slips exceeded the AASHTO limit of one-sixth of the cable diameter. The maximum cable slip was observed at the ground end of B12W, and had increased from 1.5 inches in May 2018 to over 1.75 inches in September 2020 (Figure 24).

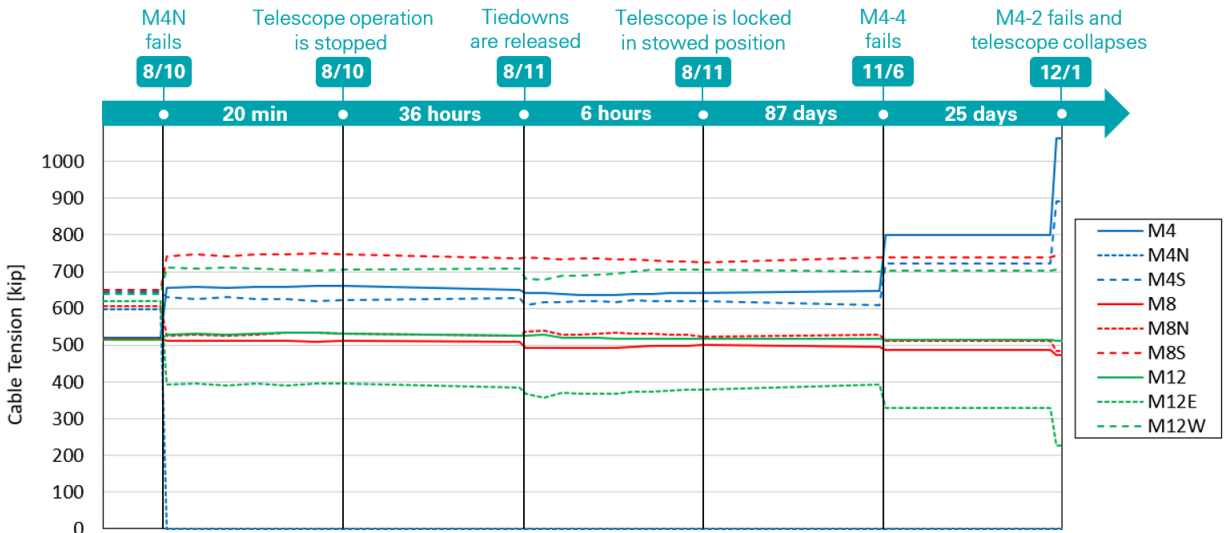
The M4N failure had a more significant impact on the redistribution of cable tensions than the M4-4 failure. Since M4N was an isolated cable, its failure resulted in an imbalance in the suspended structure. The suspended structure rotated to reach a new balance state resulting in increased and decreased tensions in the rest of the cable system. M4-4 ran in parallel with three other original M4 cables. As a result, when M4-4 failed, its tension was primarily redistributed to the three other M4 cables.

Figure 43: Tension in main cables between first cable failure and collapse.

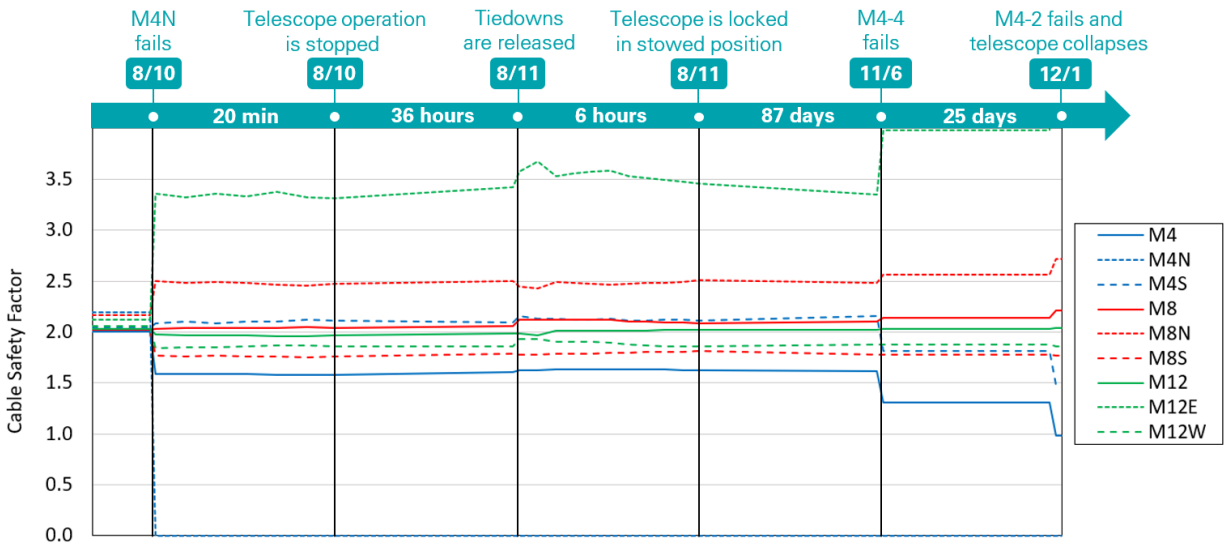
Figure 44: Safety factor in main cables between first cable failure and collapse.

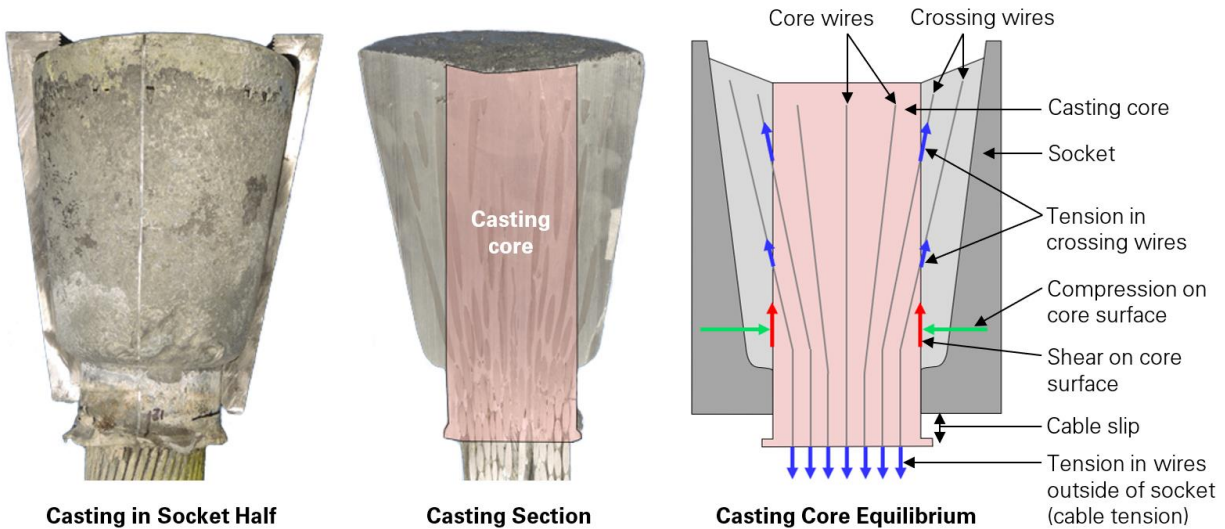
In a zinc-filled spelter socket, the cable tension is transferred to the socket through a zinc casting. In the telescope's sockets that failed or exhibited the largest cable slip, we observed the displacement of a cylindrical *core* within the casting. If we consider the forces acting on this core (Figure 45), the cable tension is resisted by shear stress on the core surface and/or tension in the wires that cross through the

core surface. These wires are referred to as the *crossing wires*, and are typically part of the outer layers of the cable.

Figure 45: Equilibrium of socket casting core (photos: Socotec).

The cable slips observed on the telescope's sockets are the result of two mechanisms. First, the pre-stretching and/or initial loading of the cable caused the zinc casting to shift and deform to become tightly wedged into the socket. This is expected to occur in any zinc-filled spelter socket, and to result in a relatively small cable slip (up to one sixth of the cable diameter per AASHTO<sup>17</sup>). In the telescope's sockets that were cut open, we observed that the cable slip had increased due to a displacement of the casting's core. This second mechanism caused the large cable slips observed on the telescope's sockets, and is the focus of our analysis.

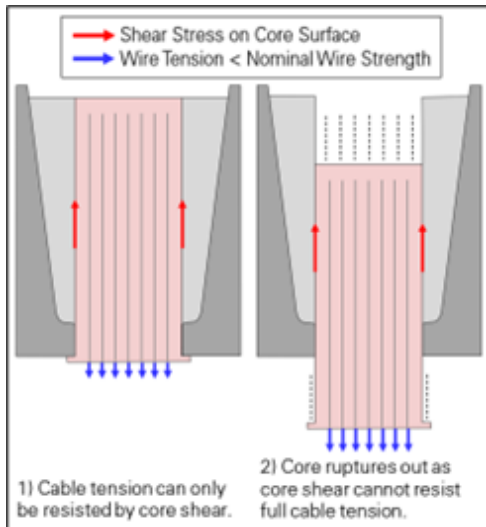
A key parameter affecting the cable slip is therefore the wire broom geometry, which includes the number of crossing wires, their length outside of the core, and their orientation with respect to the core surface. If a cable was not broomed out, the cable tension could only be resisted in shear on the core surface (Figure 46). This would result in rapid zinc flow, zinc shear failure and/or cable slip from the zinc. In any case, the cable would slip out of the socket under any substantial tension. Conversely, when the cable is broomed out, the crossing wires stretch and pick up more tension as the cable slips due to zinc flow (Figure 47). The increased tension in the crossing wires decreases the shear stress on the core, which slows down and effectively stops the zinc flow and cable slip. This, however, is only possible if the crossing wires have a sufficient capacity collectively to resist the full cable tension.

Figure 46: Case 0 – Core rupture in absence of wire broom.

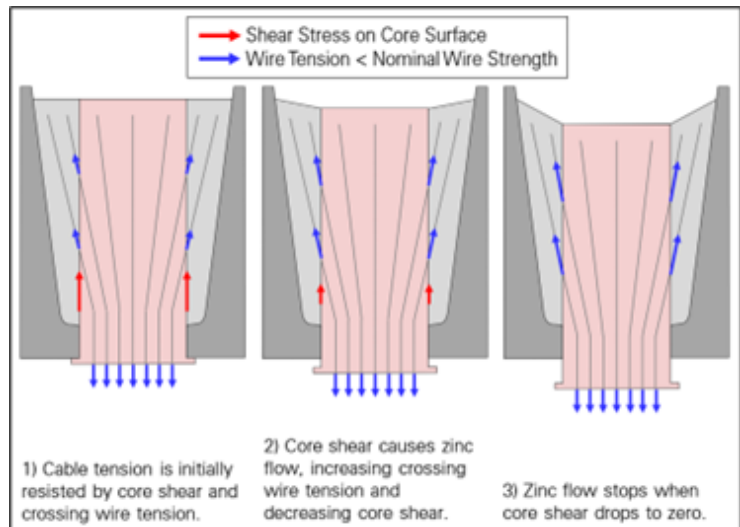
Figure 47: Case 1 – Limited cable slip when crossing wires can resist full cable tension.

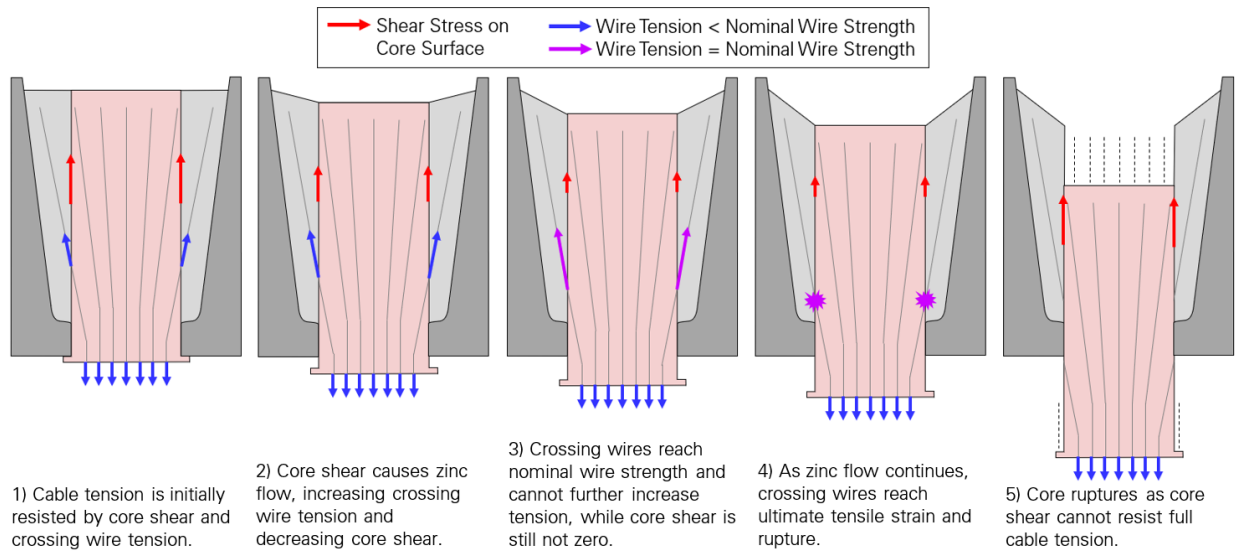
A socket where the crossing wires cannot resist the full cable tension is bound to fail, and the socket's failure mode depends on whether the crossing wires are fully or partially developed. If the crossing wires are fully developed (Figure 48), they continue to stretch near the core surface as the zinc continues to flow. Some of the wires rupture when they reach their ultimate tensile strain, which increases core shear and accelerates zinc flow, leading to more wire ruptures and, eventually, to *core rupture*. If the crossing wires are partially developed, they can slip in parallel with the core instead of rupturing, leading to *core flow-out* (Figure 49). In this case, the cable continues to gradually slip out of the socket. Complete slip-out or rupture of the core will eventually occur as the contact length between cable and socket decreases and/or the zinc's strain becomes too large. Macroscopically, the socket failure is more brittle when the crossing wires are fully developed, and more ductile when the crossing wires are partially developed. Actual sockets may include both fully and partially developed crossing wires and therefore exhibit intermediate behaviors and failure modes (Figure 50).

Figure 48: Case 2 – Core rupture when crossing wires cannot resist full cable tension and are fully developed.

Four of the six sockets that were analyzed failed or were in the process of failing. The failures of sockets M4N\_T and M4-4\_T occurred in the field and involved the rupture of multiple outer wires and a significant shift or complete pull-out of the core, which corresponds to core rupture (Figure 48, page 35). The load test of socket B4S\_G was stopped after seven outer wires ruptured, indicating that the socket was on the brink of core rupture. Finally, socket B12W\_G experienced a very large cable slip as its crossing wires slipped without fracturing, which corresponds to core flow-out (Figure 49 page 35).

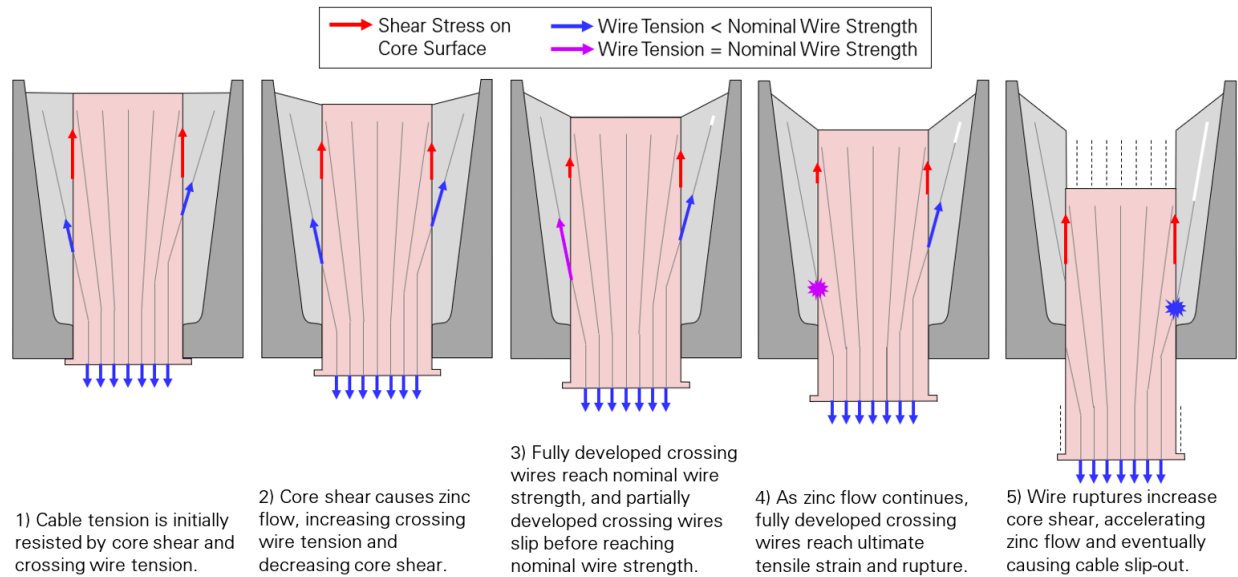
Figure 50: Case 4 – Socket failure when crossing wires cannot resist full cable tension and include both fully and partially developed wires.

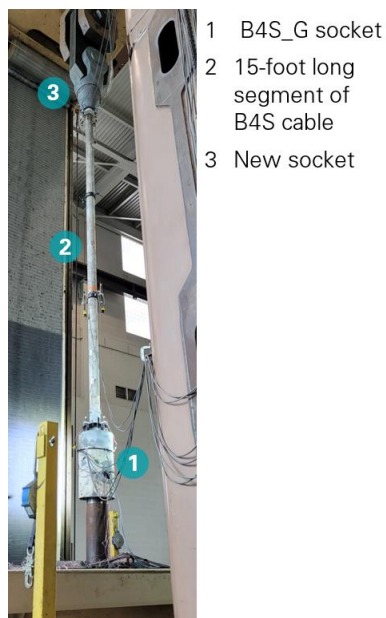
Socket B4S\_G was recovered from the collapsed telescope with 15 feet of cable attached. The socket was generally in good condition, had no visible wire breaks, and exhibited an intermediate cable slip of 0.875 inch. The free end of the cable was cast in a new zinc-filled spelter socket, and the specimen was installed in a test frame (Figure 55).

Figure 55: Socket and cable specimen in load testing machine.

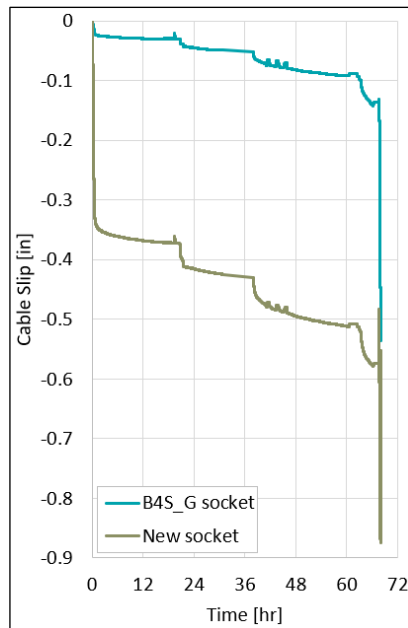
The zinc flow is non-recoverable, as was observed in the socket load test. The cable slip was monitored throughout the test with four displacement sensors at each socket (Figure 59). Plastic flow occurred in both sockets over the course of each hold, and the flow rate increased with the load. The cable slips resulting from the plastic flow were different between the new and existing sockets, although the cable tension was the same in both sockets. During the initial loading, the cable slip was more than 10 times larger at the new socket (0.35 inch) than at B4S\_G (0.03 inch). This is due to the zinc casting of the new socket being wedged into the socket for the first time to achieve load transfer. When the load was increased to the next two levels, the additional cable slip remained larger in the new socket but the difference with B4S\_G was less significant. For each load level, the cable continued to slip at both sockets while the load was held constant. This is evidence of time-dependent deformations occurring in the zinc castings. During the final loading to failure, the cable slip increased more at B4S\_G (0.40 inch) than the new socket (0.27 inch). Considering the pre-existing slip of B4S\_G (0.875 inch), the total cable slip at the end of the test was 1.375 inch at B4S\_G, and 0.85 inch at the new socket. This is consistent with the socket behavior previously introduced (Figure 48 page 35), where a socket exhibits significant cable slip before failing. In addition, the total slip of 1.375 inch is relatively close to the last known slip of 1.125 inch at the first telescope socket that failed (M4N\_T). The slip rate increased substantially in B4S\_G once the cable tension exceeded 75 percent of the Minimum Breaking Strength, and it was clear that the cable was pulling from the socket.

Figure 59: Average cable slip per socket.

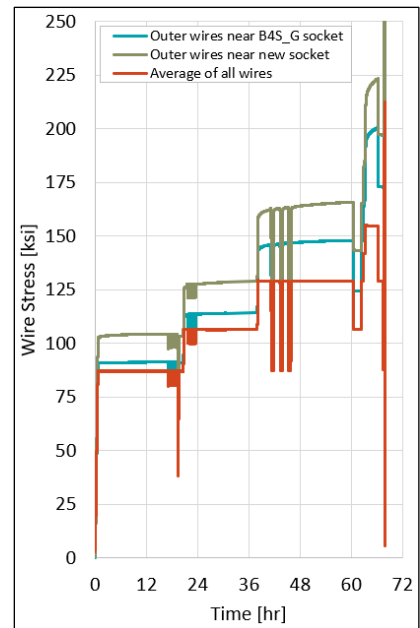
The stress in several outer wires near both sockets was monitored throughout the test with strain gages, while the average cable stress is known from the applied load (Figure 60). Under each increased load, the stress in the outer wires increased disproportionately more than in the inner wires. The outer wire stress is higher than the average cable stress at both sockets, and the difference is generally consistent with the measured cable slip. This is consistent with the socket behavior previously introduced (Figure 47 to Figure 50, pages 34 to 36), where the cable slip causes the tension to increase in the outer wires.

Figure 60: Outer wire stress vs. average cable stress.

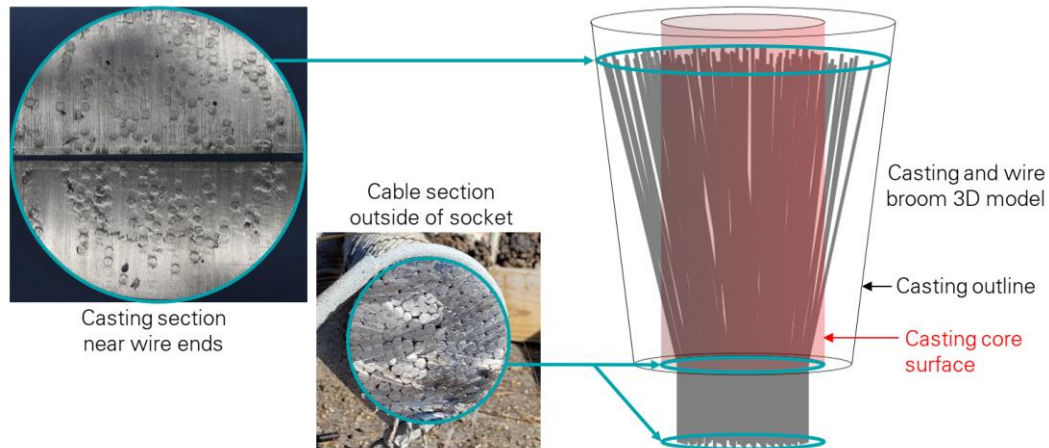
The wire broom geometry must be known to calculate the capacity of the crossing wires. The wire broom geometry was revealed from transverse cuts in the casting of six telescope sockets (Figure 61,

Figure 61: Construction of broom geometry from cable and casting sections (*casting section photo: Socotec*).

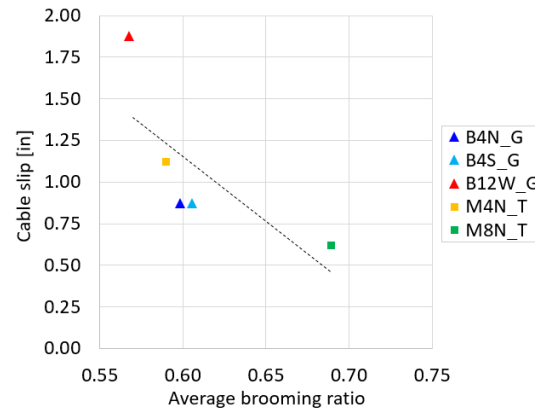
To characterize the broom geometry, we define a wire's *brooming ratio* as the wire's distance to the central axis ( $r$ ) divided by the casting's radius ( $d$ ) in the plane containing the wire ends (Figure 63). For the five auxiliary sockets considered, the cable slip decreases as the average brooming ratio increases (Figure 64). This result is a first general correlation between wire broom and cable slip, which was further investigated.

Figure 64: Cable slip vs. average brooming ratio for five auxiliary sockets.

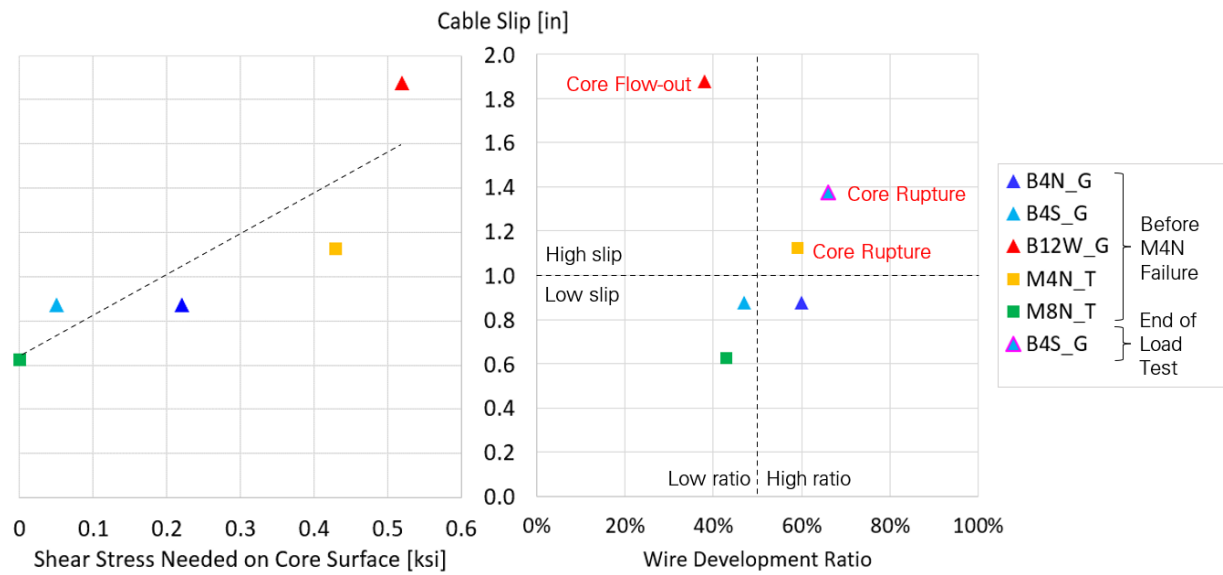
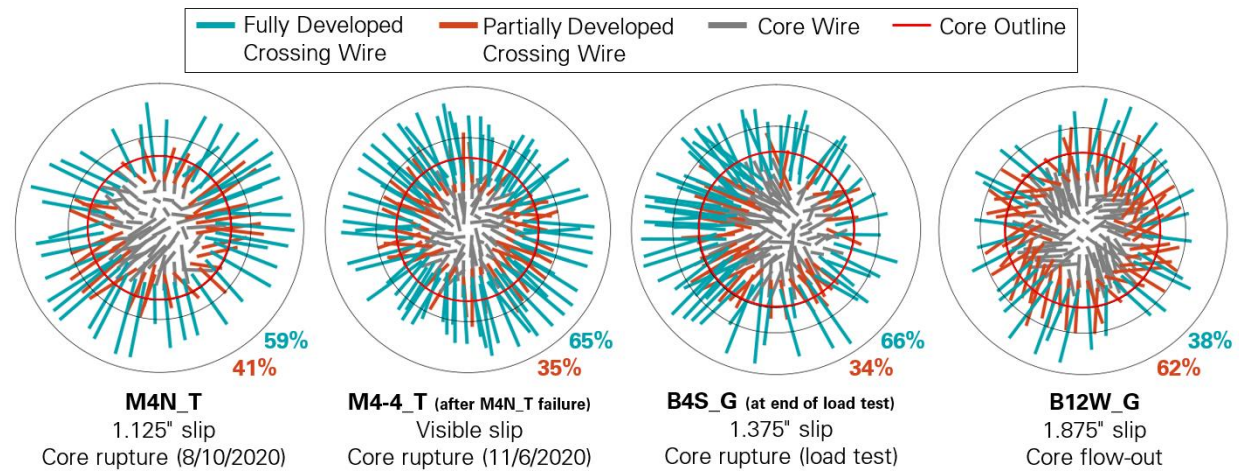
The three sockets exhibiting core rupture had a larger wire development ratio (59 to 66 percent) than the socket exhibiting core flow-out (38 percent) (Table 6, Figure 65 right, and Figure 66). This result is consistent with the socket behavior previously introduced (Figure 48 vs. Figure 49, page 35): fully developed wires lead to core fracture, while partially developed wires lead to core flow-out.

Figure 65 summarizes the observed socket behavior: if shear stress is needed on the core surface to resist the full cable tension, the zinc flows and causes cable slip over time. When the cable slip becomes too large, the socket fails in core rupture or core flow-out depending on whether the crossing wires are primarily fully developed or partially developed.

Figure 66: Fully and partially developed crossing wires in failed and failing sockets.
